HiSeq 3000 and HiSeq 4000 Instrument Software Release Notes

HiSeq Control Software (HCS) 3.3.52

For HiSeq 3000 and HiSeq 4000 Systems

June 2016

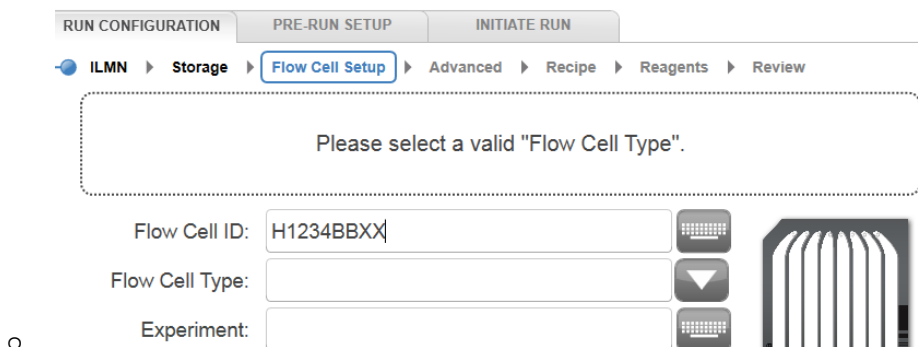
- Checkbox for Q-score binning
 - Checkbox for zipping BCL files
 - Checkbox for selecting an output folder
- When starting a run, the flowcell type box doesn't automatically populate in the Flow cell set up screen, unlike the previous HCS previous version. The user is required to select the appropriate flow cell type (Paired read or Single read) so that the correct recipe for indexing is called designated in HCS
